## **The impact of electric overhead radiant heating on the indoor environment of historic churches**

The impact of electric overhead radiant heaters on the microclimate, air flows, transport and deposition of suspended particulate matter (SPM) was monitored between March 2004 and March 2005 in the historic churches of Saint Michael Archangel in Szalowa and Saint Catherine in Cracow (Poland). The measurements show that although irradiation at the floor level increases temperature and reduces relative humidity in the interior of the church, the effect out of the heated zone and for the surfaces sheltered from irradiation is very limited, i.e. their extent is comparable with natural fluctuations inherent to the local climate of the church. The radiant heaters proved to generate little convective flow of the air. Therefore, the heating system was not found to increase the concentration of SPM indoors; in particular, no re-suspension of particles already present in the church was observed. This work has demonstrated that the overhead radiant heaters are capable of providing localised heat to the areas where people congregate without adversely affecting painted walls and the works of a

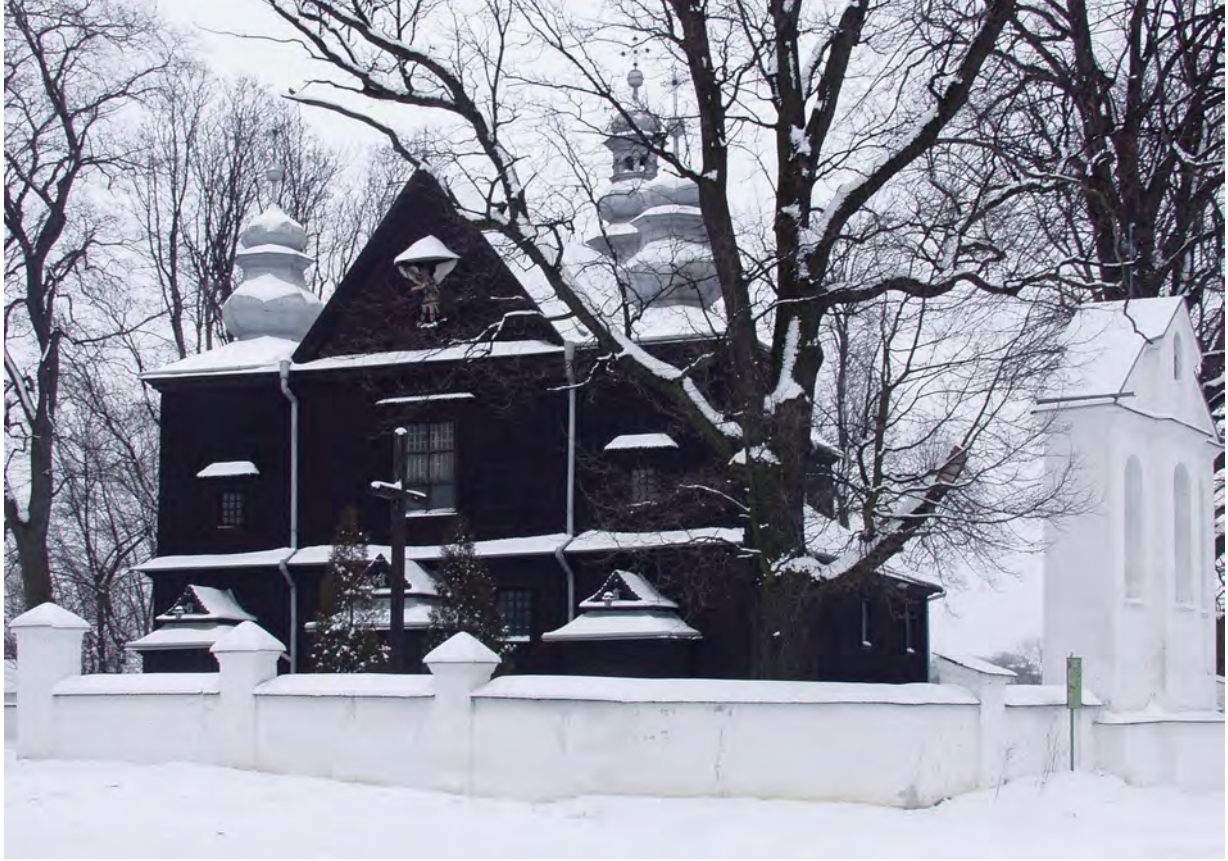
**Fig. 1.** Wooden church of St. Michael Archangel in Szalowa, Poland, 1736 - 1756.

The primary monitoring site was the wooden church of St. Michael Archangel in Szalowa located at the fringe of the West Carpathians around 150 km south-east of Cracow, Poland ( Fig. 1). A wooden church was selected for this study for several reasons. Wooden religious buildings are a unique legacy of art and architecture of high significance to Central, Eastern and Northern Europe. Furthermore, wooden churches are relatively open structures with fast air-exchange between indoors and outdoors and almost no capacity to store heat in the walls. Therefore, their indoor microclimate is particularly strongly governed by the fluctuating climatic conditions outside. On the other hand, paintings on wood and wooden decorative objects are particularly vulnerable to deterioration when exposed to lower levels of RH than the ideal in theory [9, 10], and than the RH to which the interiors were exposed in the past. As a result, any heating arrangement may have more adverse effects in a wooden church than in a brick or a stone church with a more airtight structure.

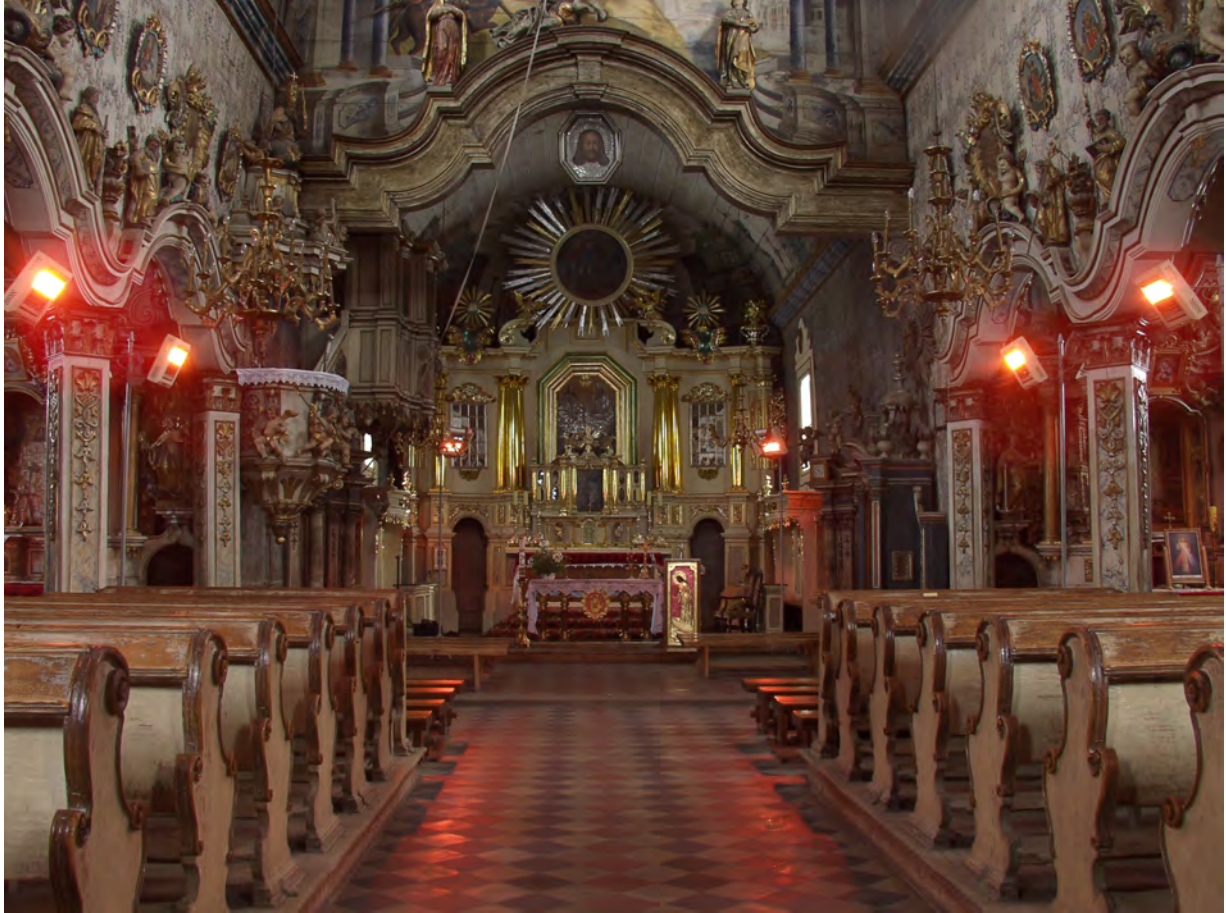
**Fig. 2.** Wooden church of St. Michael Archangel in Szalowa, Poland. View of the interior with overhead radiant electric heaters operating.

The existing heating system is installed for the winter period usually from November until March. It consists of radiant electric heaters mounted on the metal rods at a height of about 3.5 m above the floor level ( Fig. 2). There are altogether eight rods in the nave and two rods in the chancel, heating the altar area. Each rod holds two radiant heaters of 2 kW power, which gives a total power of 40 kW during the church services. The rods with the heaters are bolted to the stone floor at the edge of the nave so that one radiator heats people sitting in the pews and the other provides heat to people standing in the aisles ( Fig. 3). The heating is switched on around 10 min before the service and switched off after 45 min.

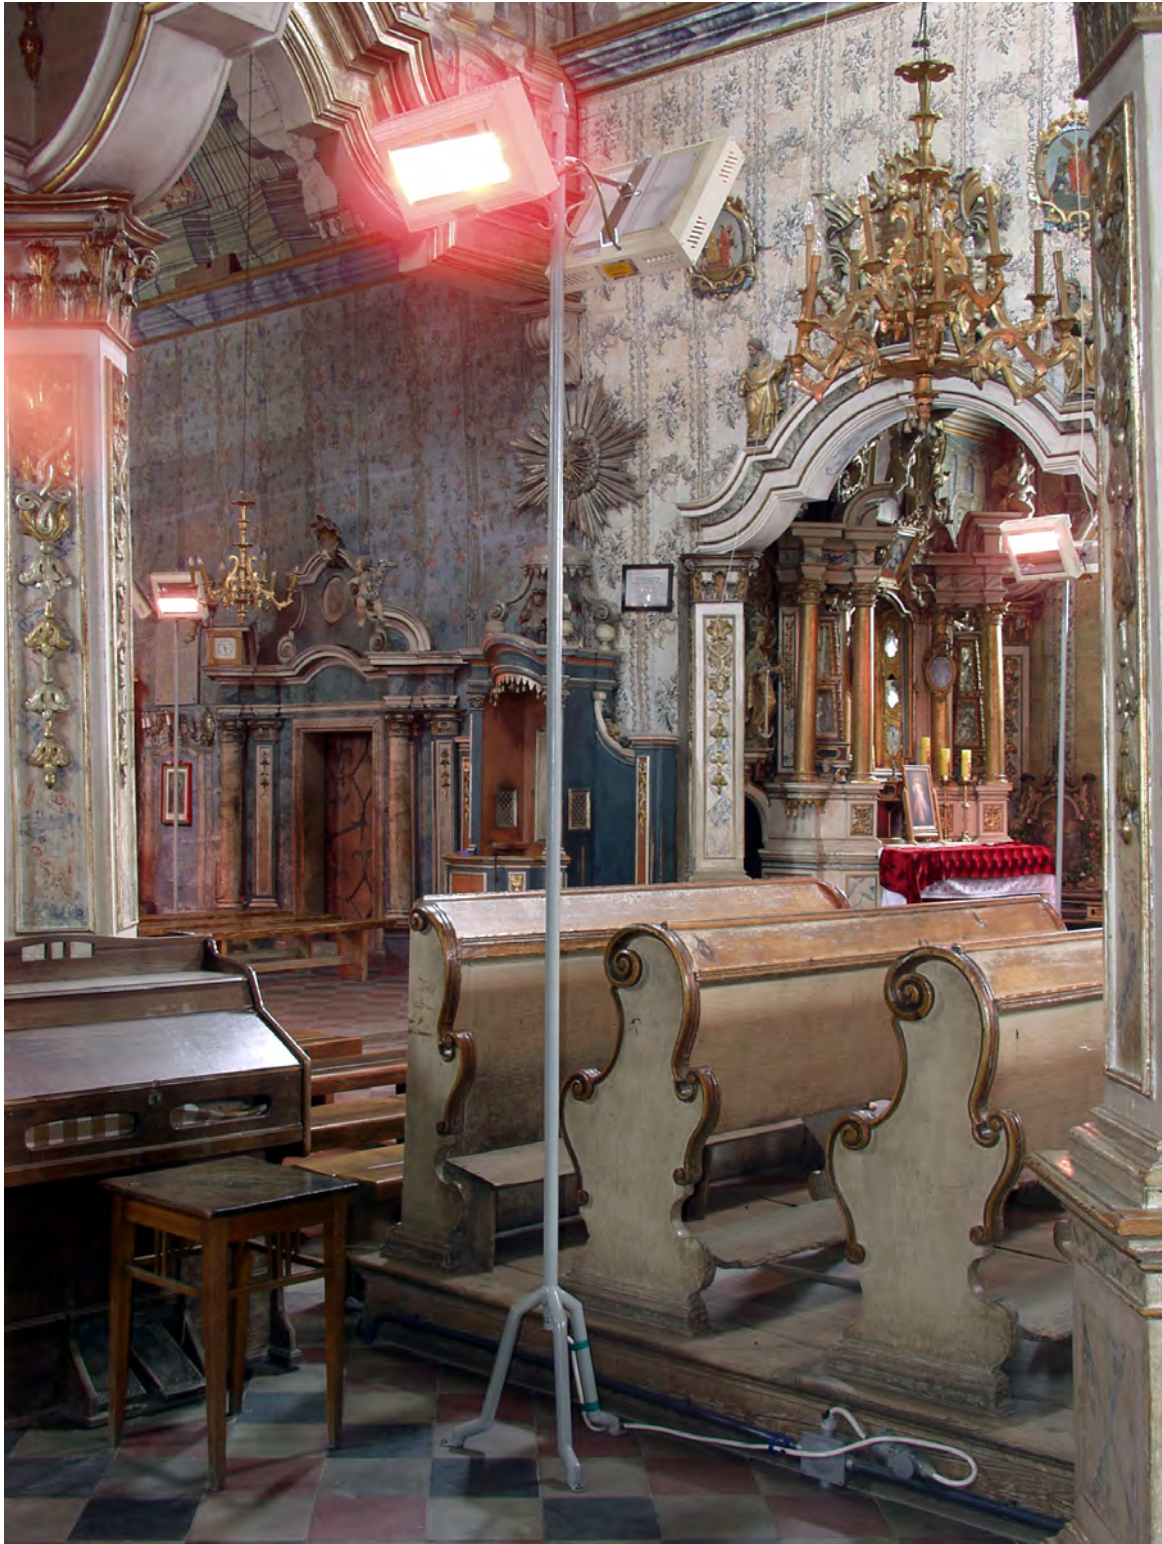
**Fig. 3.** Details of mounting the heaters on the metal rods at the height of about 3.5 m above the floor.

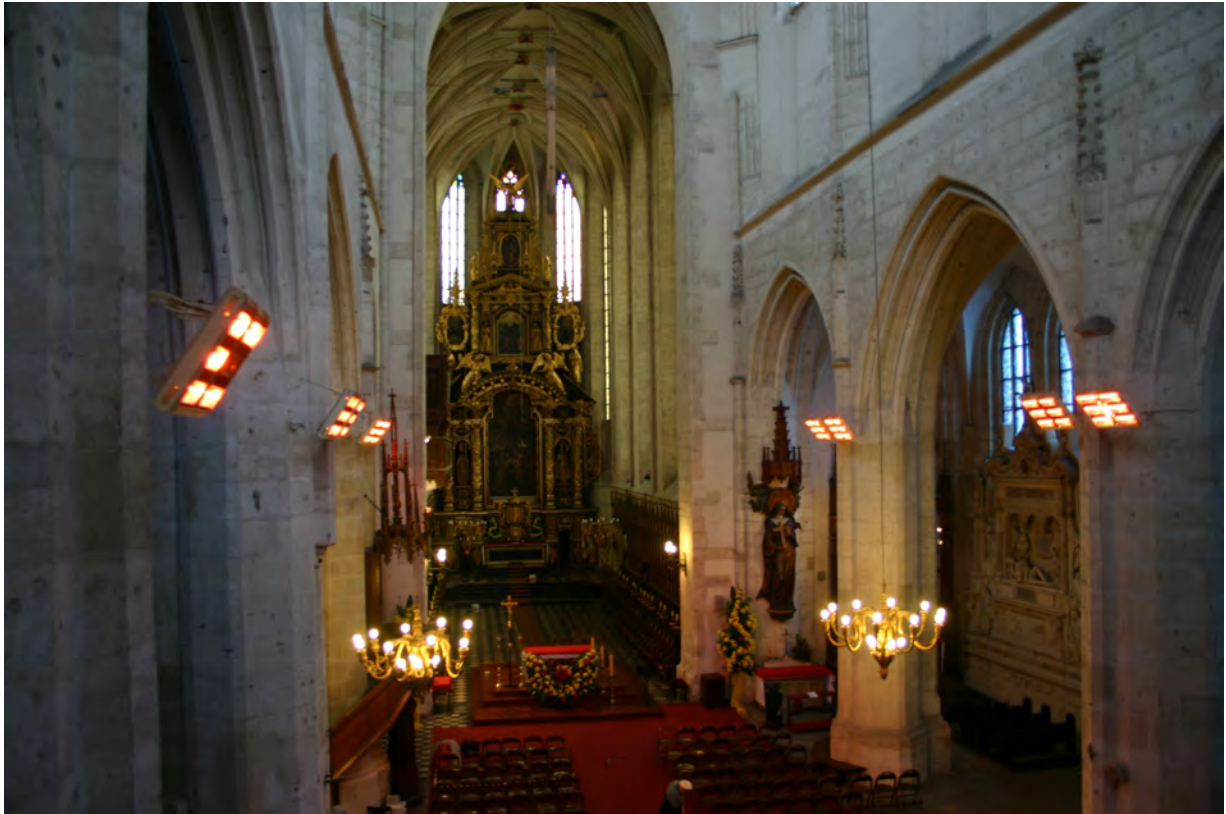
**Fig. 4.** Main nave of church of St. Catherine in Cracow, Poland, 1365e1400. Electric heaters, comprising six radiant tubes each, are mounted permanently at a height of 7 m above the floor.

The monumental brick church of St. Catherine in Cracow was used as the second site, as it had a solid, more airtight building envelope hindering the air-exchange and offering better heat-buffering capacities. The church is a Gothic basilica, with three naves, built from 1365 to 1400. The heating system for the main nave consists of ten electric heaters mounted permanently at a height of 7 m above the floor ( Fig. 4). Each heater comprises six radiant tubes of 2 kW, so the total operating power during services is 120 kW. Similarly to the church in Szalowa, the heating system operates for around 1 h during the service.

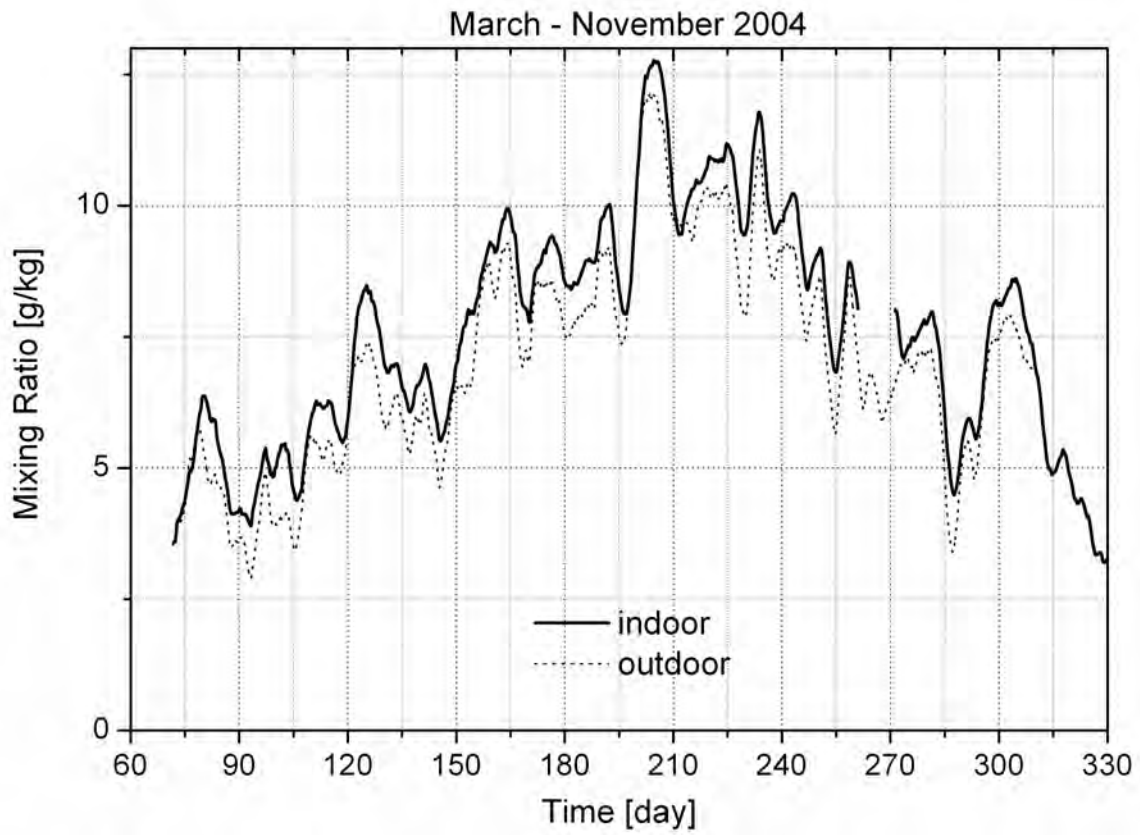
**Fig. 5.** Indoor and outdoor moisture contents between March and November 2004 expressed as humidity mixing ratio (MR). The plots were smoothed by calculating an average of the data points every five minutes in the two adjacent 24 h periods.

To assess the destabilisation of the microclimatic conditions introduced by heating, it is important to know the local natural indoor climate to which the building and its content have adapted over their long-term exposure. A monitoring period between March and November in 2004 was selected as a reference, during which no heating system was operated. The microclimate in the wooden church in Szalowa is essentially governed by the fluctuating climatic conditions outside. A vigorous ingress of outside air into the interior is possible through the relatively open wooden structure and doors. The natural ventilation rate in the church, when the heating was off, was around 3 air changes per hour (ACH), which can be regarded as an extremely high air-exchange rate (AER). For example, AERs of around 0.1 is typical of churches with airtight plastered stone vaults and AERs of 0.5–0.75 for churches with wooden vaults [2]. A high AER between indoors and outdoors is illustrated in Fig. 5 by plots of the corresponding internal and external moisture contents in 2004, expressed as the humidity mixing ratio (MR), i.e. grams of water vapour per kilogramme of dry air. The MR inside increased from about 3 g/kg in March to 13 g/kg in August, which was in accordance with the external seasonal variations. The MR values indoors were consistently higher than outdoors, which pointed to internal sources of extra moisture in the church, people visiting the church being the most important. Fig. 6 shows plots of T and RH inside and outside the church for the same period. The interior T increased from a minimum value of 0 °C in March to 25 °C in August and September. RH did not show any distinct seasonal variation and fluctuated irregularly around an average of 70%. The outside climatic variations were smoothed inside due to buffering by wood. The buffering effect of wood is particularly evident when short time variations are analysed ( Fig. 7). During June 2004, the daily variations of T and RH could be up to 5 °C and 14%, respectively when compared to the values of 24 °C and 80% outdoors. The diurnal cycles in RH were thus particularly effectively buffered by the cyclic release and absorption of moisture by the wood. The capacity of wood to release moisture could be exhausted, as exemplified by a dry period in March 2004 when the RH level moved gradually from 75 to 45%, the lowest RH value recorded in the church for the monitoring period ( Fig. 8).

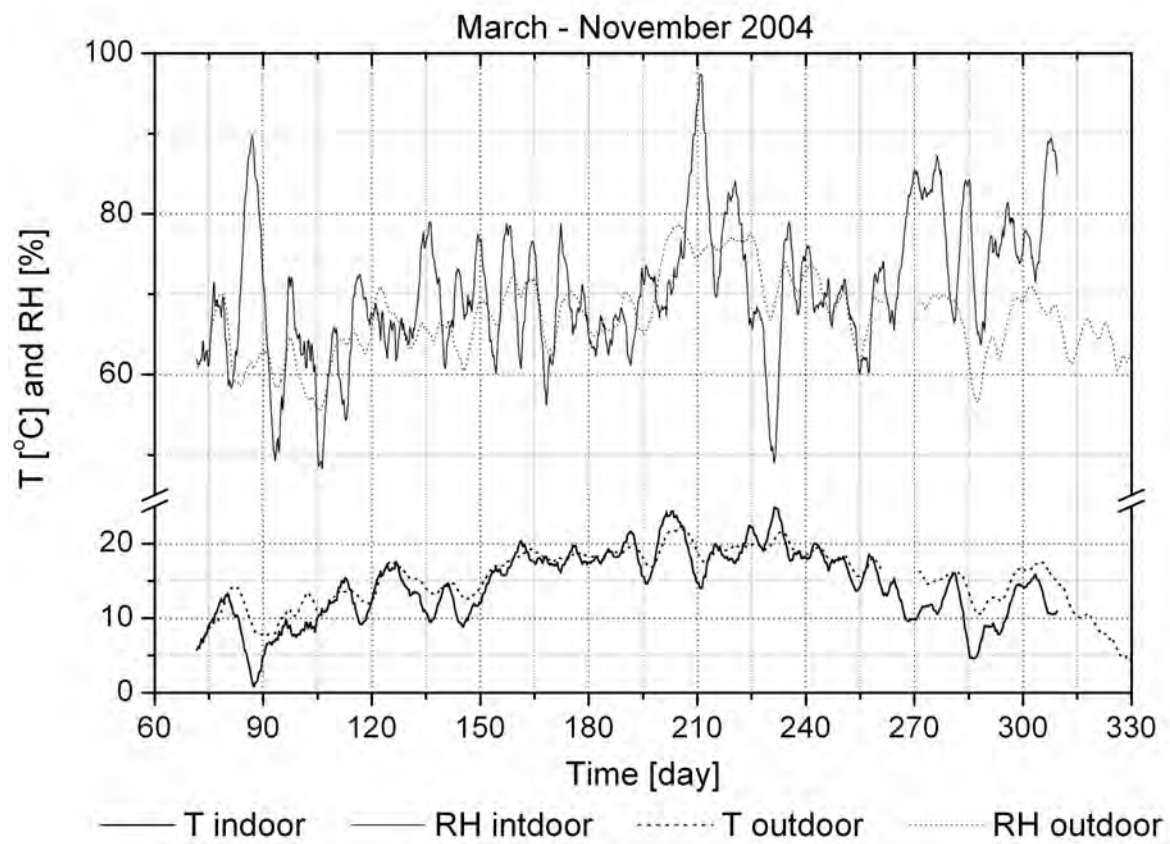
**Fig. 6.** Indoor and outdoor climates between March and November 2004 as plots of T and RH smoothed as in Fig. 5.

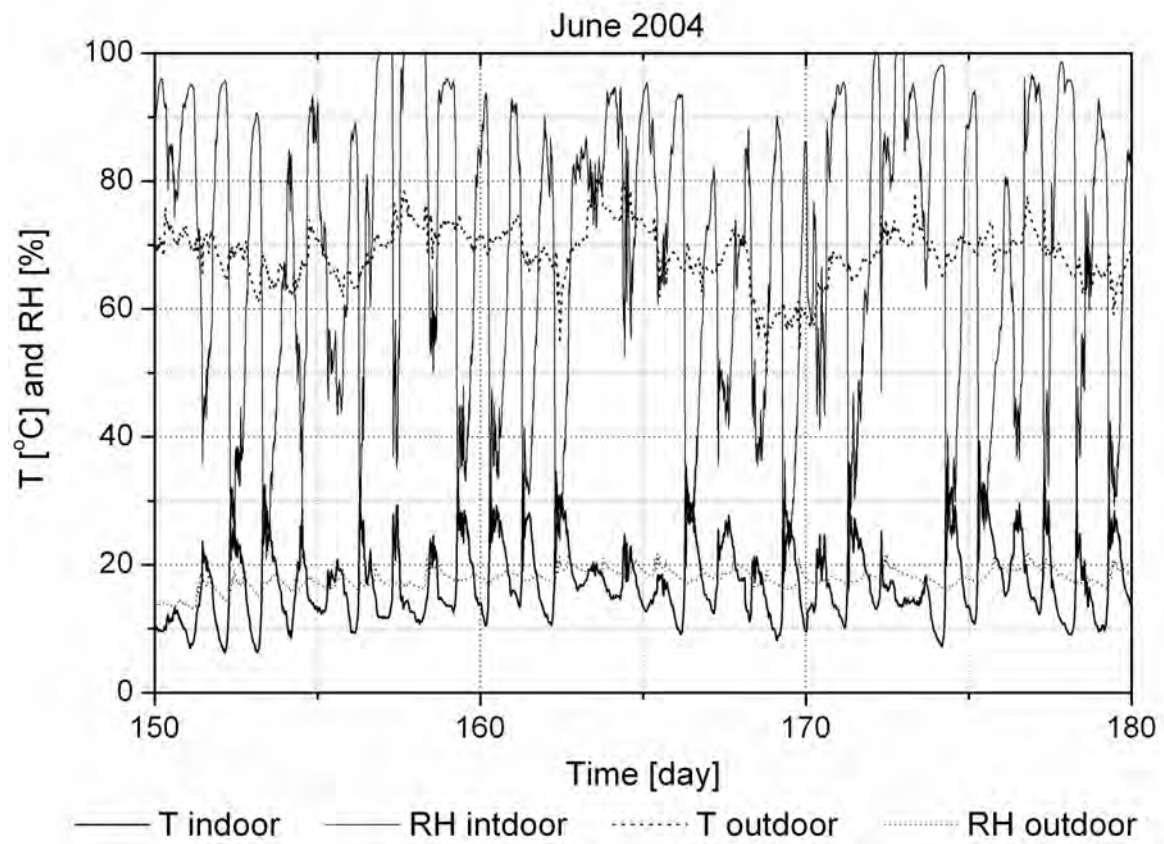
**Fig. 7.** Indoor and outdoor climate in June 2004 as plots of five-minute values of T and RH.

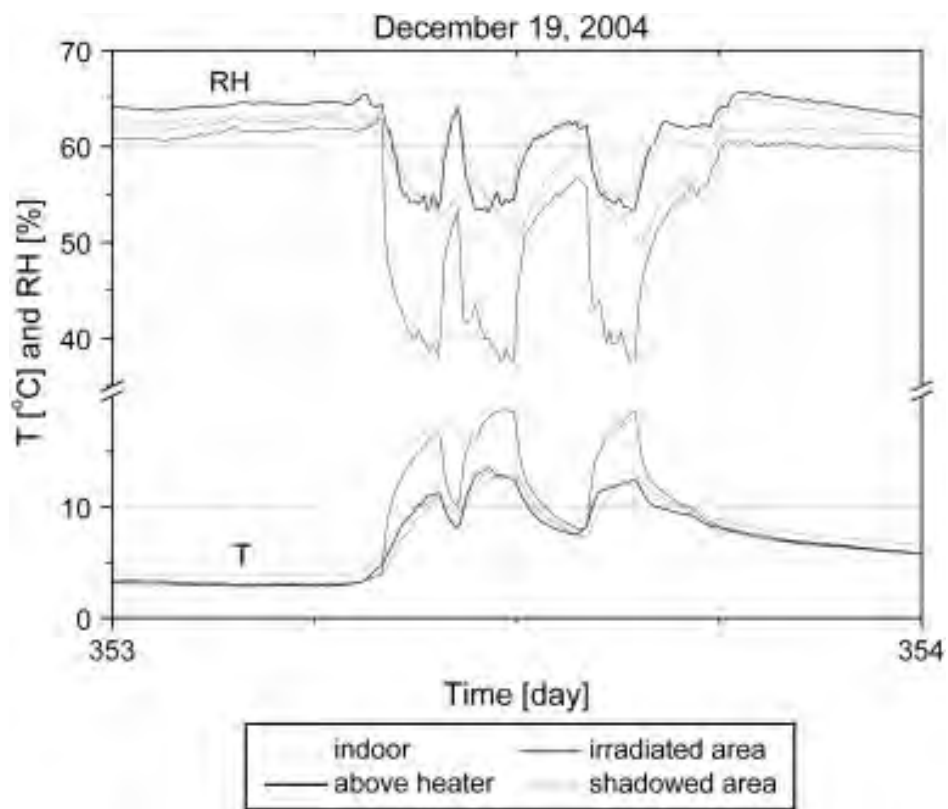
**Fig. 9.** Short-term variations in T and RH due to heating episodes on December 19, 2004 recorded at several locations in the church.

Measurements made during the winter 2004/2005 period provided direct information on the disturbance of the microclimatic conditions introduced by indoor heating. Fig. 9 shows characteristic short-term variations introduced by several heating episodes recorded during

December 2004 when the church was frequently used for services. As expected, the T of the irradiated surface rose by around 13 °C, when the heating was on, and the RH in the air layer in contact with this surface dropped by more than 20%. The changes in T and RH were considerably smaller in the zone which was not irradiated, i.e. 7 °C and 9% respectively. The RH variations were smaller than one would expect from the T changes as they were compensated for by the release of moisture by the materials irradiated. The release is clearly visible in Fig. 10 which shows variability of the indoor MR during heating.

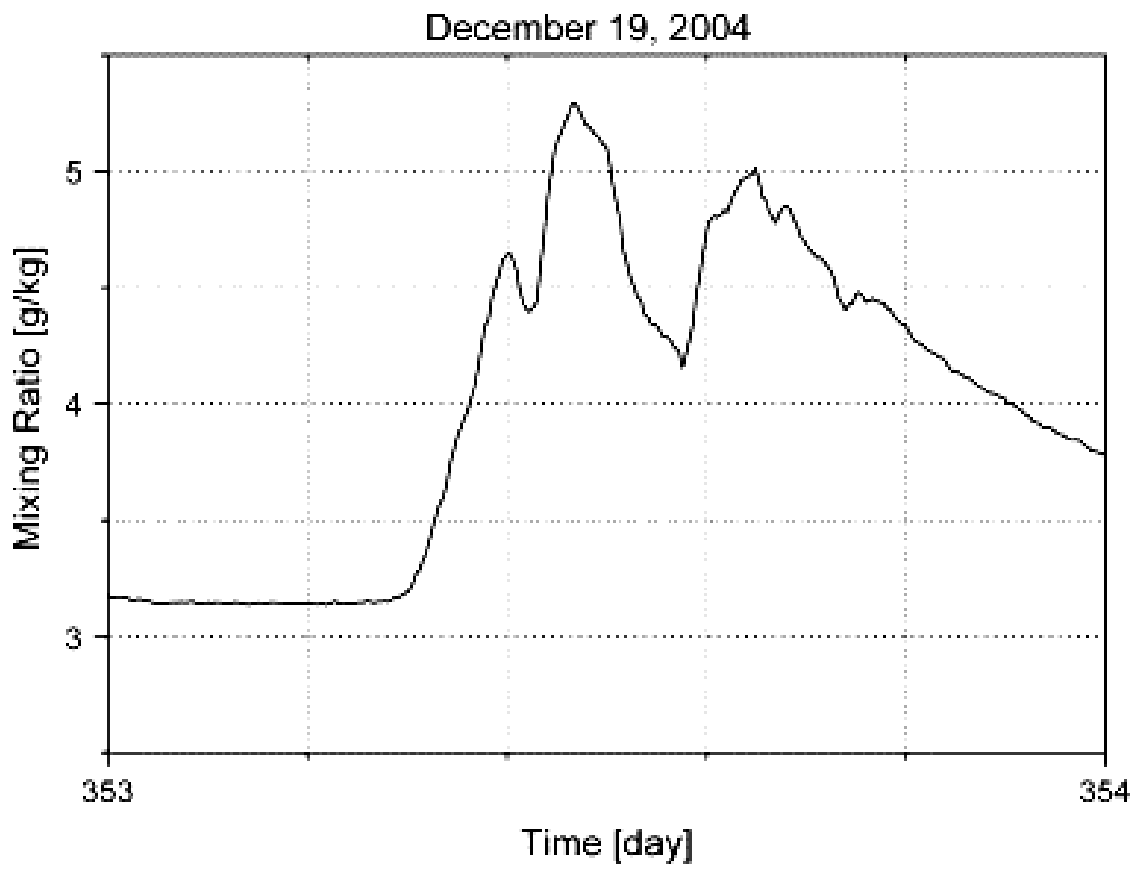
**Fig. 10.** Variation in the indoor moisture content expressed as humidity mixing ratio (MR) due to the heating episodes analysed in Fig.9.

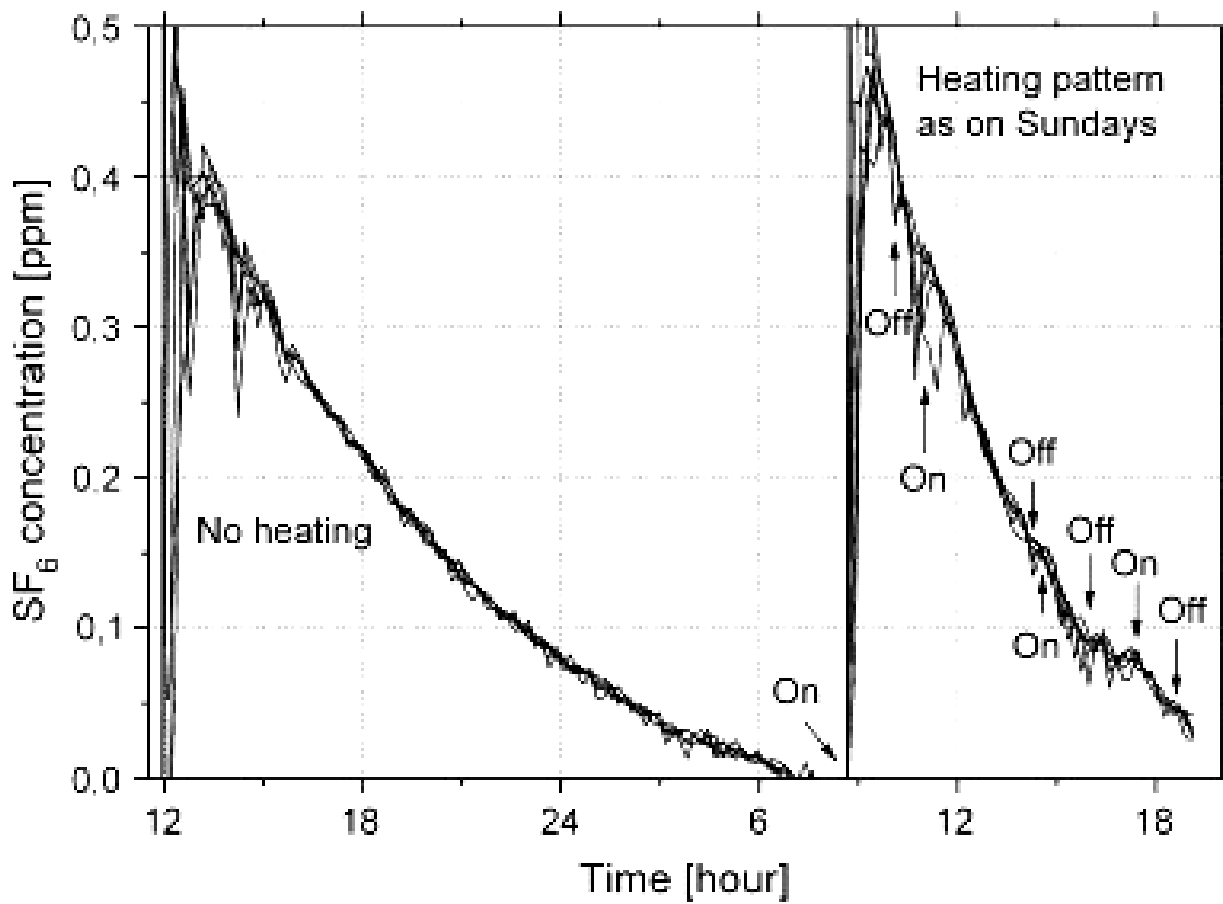
**Fig. 11.** Evolution of the concentration profiles of SF<sub>6</sub> tracer at six measurement points in the church of St Catherine in Cracow, first unheated, and then heated following the pattern of use on Sundays.

The ventilation rate for the large brick church in Cracow was much lower; 0.17 ACH. For this church, a fast and complete mixing of the released SF<sub>6</sub> was observed. The heating promoted both a faster transport of air within the church and a faster removal of the gas from the church, as shown in Fig. 11, the calculated ventilation rate being 0.27 ACH. This value is in accordance with previous observations on the stone church of Rocca Pietore [11].

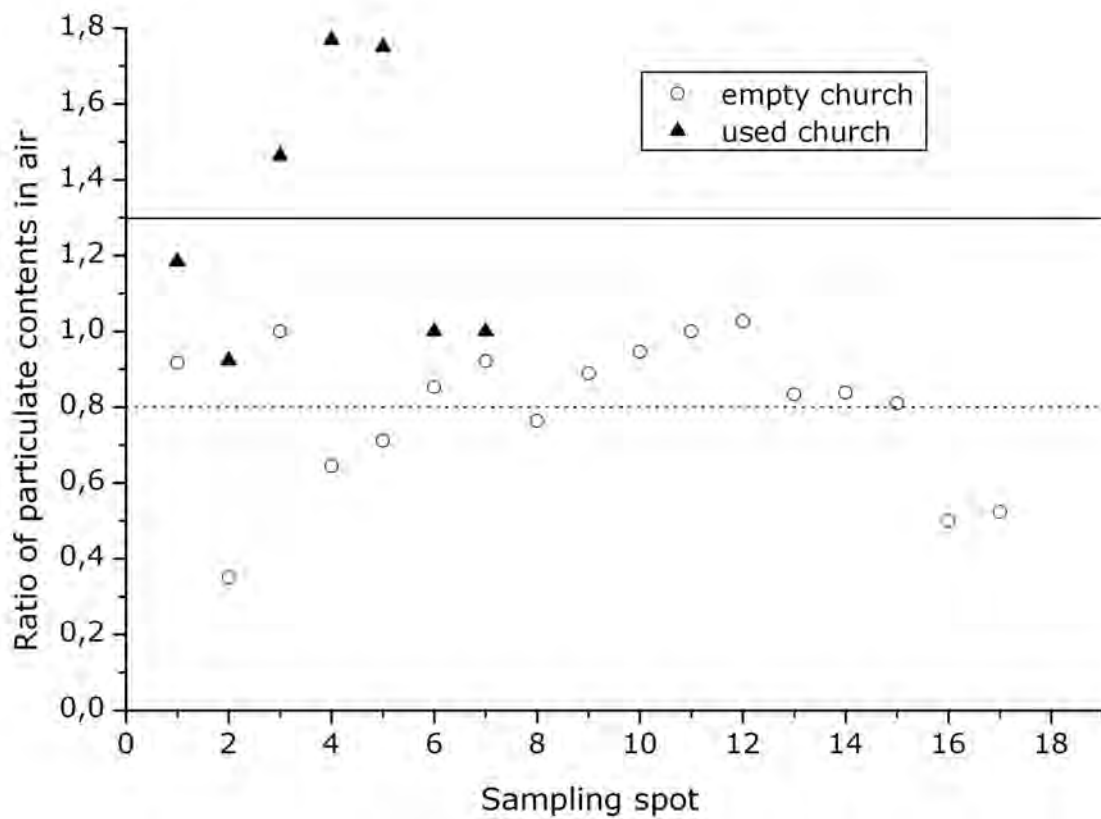
**Fig. 12.** Ratios of the indoor particulate contents during heating to those in the absence of heating in the adjacent days, determined during three sampling campaigns in both churches.

adjacent days were calculated for each sampling point and the values obtained are shown in Fig. 12, separately for empty churches and churches on Sundays with high attendance of the congregation for services. The average values were  $0.8 \pm 0.2$  for empty churches and  $1.2 \pm 0.4$  for churches used on Sundays; the uncertainties are standard deviations of the mean values. It is clear that within the standard deviation the heating system does not increase the amounts of SPM in the indoor air. A slight increase in the ratio of particulate content on Sundays when compared to the unheated empty church is obviously due to the intense use of the church when external particles are brought in or particles present in the interior are re-suspended by people.
